Experimental fire behaviour of precast CFRP pretensioned HPSCC slabs

Maluk, C, Terrasi, GP, Bisby, LA, Stutz, A & Hugi, E 2014, Experimental fire behaviour of precast CFRP pretensioned HPSCC slabs. in R El-Hacha (ed.), *Proceedings of the 7th International Conference on FRP Composites in Civil Engineering, CICE 2014*. International Institute for FRP in Construction (IIFC), Vancouver, 7th International Conference on FRP Composites in Civil Engineering, CICE 2014, Vancouver, Canada, 20/08/14.

EXPERIMENTAL FIRE BEHAVIOUR OF PRECAST CFRP PRETENSIONED HPSCC SLABS

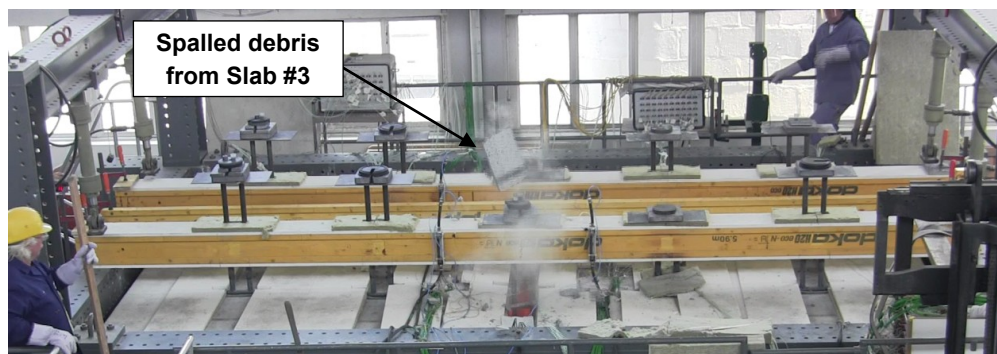
Failure of slabs #2 and #3, both cast from the same concrete batch (mix 342), was driven by the occurrence of a single explosive heat-induced concrete spalling event at minute 12 and 22, respectively (refer to Table 2). Immediately after spalling, the slabs failed suddenly. A snapshot from the video sequence recorded during testing shows the exact moment at which spalling occurred for Slab #3 (Figure

1) and shows the violence with which pieces of concrete were expelled from the furnace. Slab #2 suffered early failure at minute 12 due to a single explosive spalling event while Slab #1, which was virtually identical to Slab #2, failed due to loss of bond strength at minute 42 without significant spalling being observed (refer to Table 2). Whilst a full analysis of the reasons for this cannot be included in the current paper, through-thickness temperature measurements showed a more rapid temperature increase within Slab #2 compared with Slab #1 (both were 45 mm thick); this is thought to be associated with the occurrence of spalling and due to slight non-uniformity of thermal exposure within the furnace. Likewise, Slab #3, which also suffered from spalling, showed more rapid temperature increase at midspan.

Fig. 1 – Testing Furnace, Explosive Spalling and Imminent Failure of Slab #3 at 22' 10".

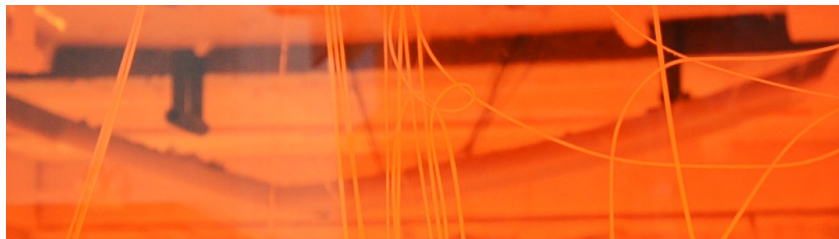
Slab #4 (45 mm thick) and Slab #5 (60 mm thick), both of which had CFRP grids in their prestress transfer zones, failed when midspan temperature at the lower edge of a centre CFRP tendon was about 600°C. Slab #1, which had no CFRP grids, failed when midspan temperature at the lower edge of a centre CFRP tendon was about 450°C. This indicates a possible increase in bond strength at elevated temperature provided by the presence of CFRP grids at the prestress transfer zones. Figure 3 shows a bottom view (i.e. view from inside the furnace) of Slab #4 at the moment of failure.

Fig. 3 – Failure of Slab #4 at 50' 27\"
